SERIOUS INCIDENT

Aircraft Type and Registration:	Boeing 737-8Q8, YR-BMF	
No & Type of Engines:	2 CFM56 7B24/3 turbofan engines	
Year of Manufacture:	1999 (Serial no: 28220)	
Date & Time (UTC):	28 July 2018 at 1010 hrs	
Location:	Birmingham Airport	
Type of Flight:	Commercial Air Transport (Passenger)	
Persons on Board:	Crew - 6	Passengers - 190
Injuries:	Crew - None	Passengers - None
Nature of Damage:	APU drain mast and tail skid components damaged	
Commander's Licence:	Airline Transport Pilot's Licence	
Commander's Age:	60 years	
Commander's Flying Experience:	17,481 hours (of which 7,272 were on type) Last 90 days - 109 hours Last 28 days - 68 hours	
Information Source:	Aircraft Accident Report Form submitted by the pilot and further enquiries by the AAIB

Synopsis

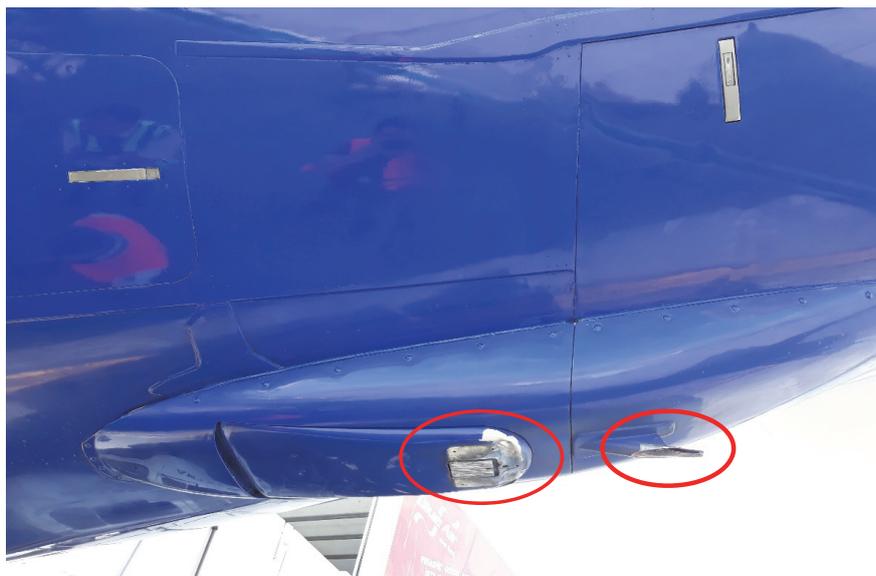
Figure 1

After landing the commander asked the aircraft engineers to examine the aircraft for evidence of a tailstrike. They discovered damage to the aircraft’s tail skid and APU drain mast (Figure 1).

Damage to underside of aircraft

During the pre-flight preparation, the commander read the ZFW from the load sheet to the co-pilot, instead of the TOW, and this was entered into the EFB. The takeoff performance data calculated consequently used a takeoff mass of about 12 tonnes less than the aircraft's actual weight. This produced takeoff speeds that were more than 10 kt less than those required. Having flown the takeoff using these slower speeds the aircraft suffered a tailstrike.

As a result of this event the operator issued Safety Information Bulletin No 7/2018 to its pilots, highlighting the background to it and highlighted the following:
